# GREEN AUDIT REPORT OF GOVERNMENT HRANGBANA COLLEGE AIZAWL

Prepared by:  
Mizoram Pollution Control Board

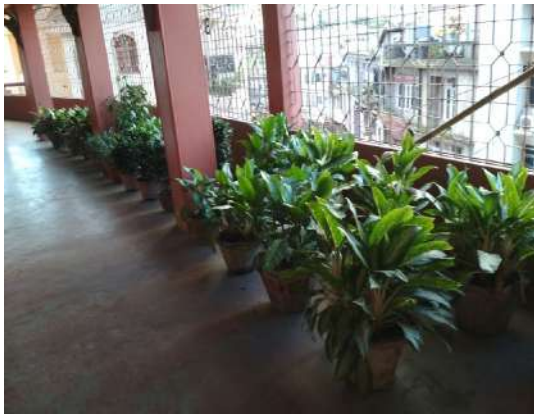
Photo 5. Indoor Plantation

Nevertheless, the greenery of the College is maintained by plantation of indoor/ potted plants within the College Building, and the adoption of the rain water harvesting technique by the College. Cleanliness and Beautification Cell

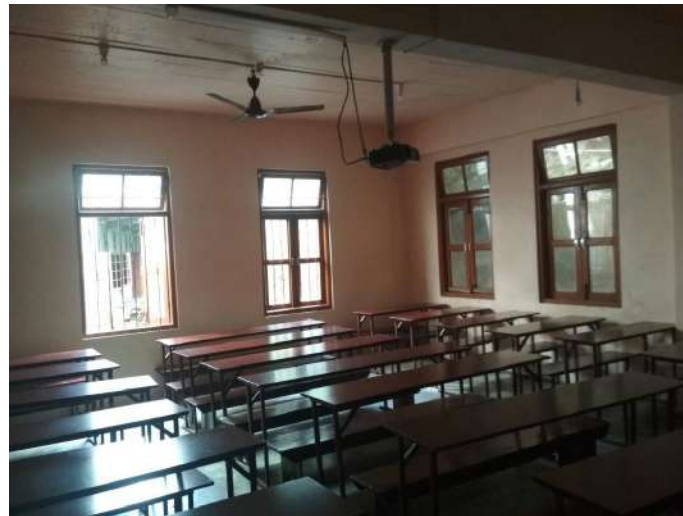
Photo 10: Classroom

To find out whether the indoor air is sufficient in all rooms, data on the area of classrooms and mechanical ventilation system was collected through measurements and the administration files. Apart from the already documented length and width of classrooms, the height was physically taken by Measuring Tape.

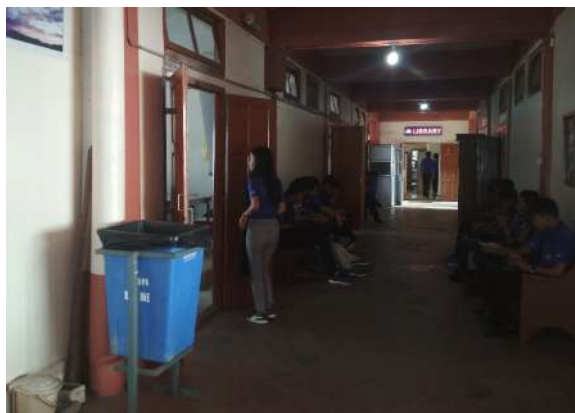
Photo11: Dust bin at the corridor

During the survey, it was found that efforts were given for maintaining the cleanliness of the campus by providing dust bins, brooms etc in each classroom. However, garbage bins provided in each classroom were not covered and few in numbers and segregation were found to be poor. All kinds of wastes are thrown altogether including waste paper, plastic bottle, tin container which could be separated for recycling or reuse.

The survey also showed that there are no students, teachers as well as the administrative staff's participation in segregation of waste, which shows a low level of awareness. **To improve this, the awareness of students, teachers and administrators needs to be increased.**

1. The wastes generated from the institution (College and Hostel) must be segregated properly and in a scientific manner i.e into degradable and bio-degradable.

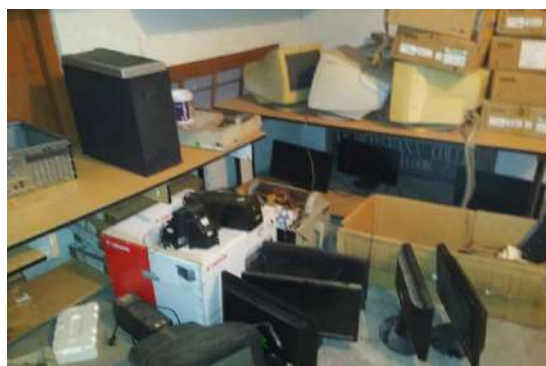
**Photo13: E- Waste generated by the institution**

During the physical inspection, the following e- wastes like Computer monitor (13 Nos.), UPS (5Nos), CPU (3Nos) and Scanner (1Nos), Speaker (2 sets), Cyclostyle (1No) were found generated by the institution.

Though the E- waste generated was not disposed scientifically, the E-waste and defective item from Computer Laboratory is being stored properly. The discarded/ written off computers, if repairable, are mended at the servicing station and donated to schools in rural area.

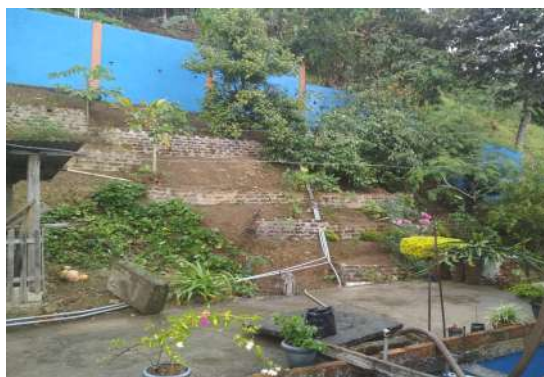
Photo17: Home Garden

A Green belt or Home Garden was maintained by the staff and students. A compost pit of 5ft. diameter and 2 ft depth was constructed near the garden where all the bio-degradable wastes are disposed. The manure from the compost pit was utilized in the garden.

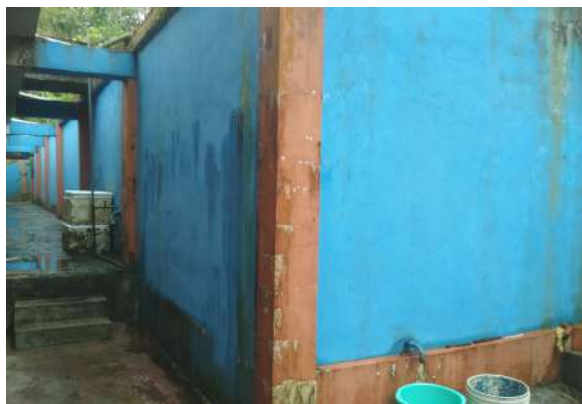
Photo19 : Water harvesting tank (Concrete)

The Hostel has one plastic tank of 4000L capacity and two water tanks (concrete) of 71358.45L and 28316 L capacity respectively which stores water from public supply and all rain water. During the inspection, the concrete water tank is nearly full which shows that the Hostel has harvested plenty of rain water apart from the average monthly public supply received. Thus, the Hostel does not face water scarcity at the time of inspection. Hence, a good score of **7** is credited out of 7.5 allotted.

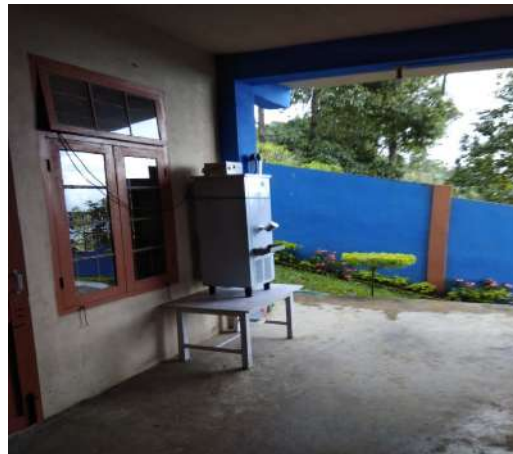
Photo20: Water Cooler at Women Hostel

The main source of waste water discharge is from cooking, cleaning, washing, gardening and sanitary purposes. On average, 61200 l of waste water per month was discharged which is equal to 53.68 lpcd which is less than the per capita per day requirement as outlined by CPHEED. During the survey, no loss of water is observed, neither by any leakages or by over flow of water from overhead tanks.

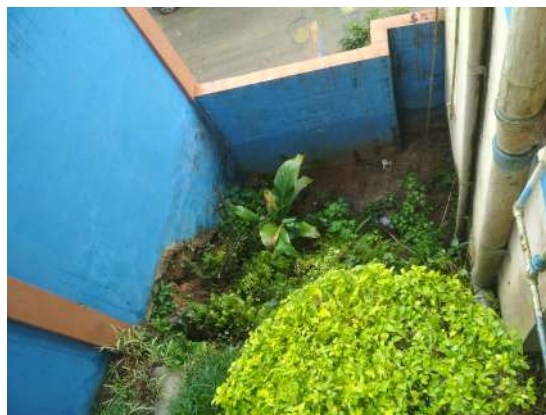
Photo 21. Water logging

It was observed that all the waste water from the bathrooms, toilets and kitchen was disposed through pipeline to the public drainage system. Though a garland drain is well constructed besides the building, it is not properly managed or maintained. During inspection, water from the drain was found logging besides the ground floor of the building which could attract flies and mosquitoes. Proper sewerage/ effluent treatment plant must be constructed in order to minimize the ground water pollution. **Therefore, 4.5 out of 7 is credited.**

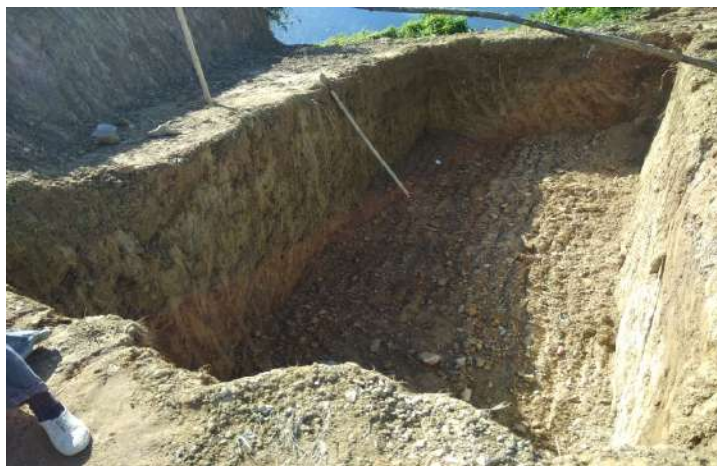
**Photo24: Water Harvesting Structure (Under Construction)**

As the facility is under construction, data on the quantity of water supplied via public supply could not be calculated. Two plastic water tank of 4000 L capacity each is installed and a 1000 L capacity tank is proposed to be installed. However it was found that a rain water harvesting tank of 1680 cu.ft i.e. about 47,572 L capacity is under construction. **Hence, a score of 12 out of 15 is credited.**
